LINTRACK research into expansion joint behaviour

Silent Joint 500 Resa S test results

November 2009

Dr.ir. M. Huurman, ing J. Moraal

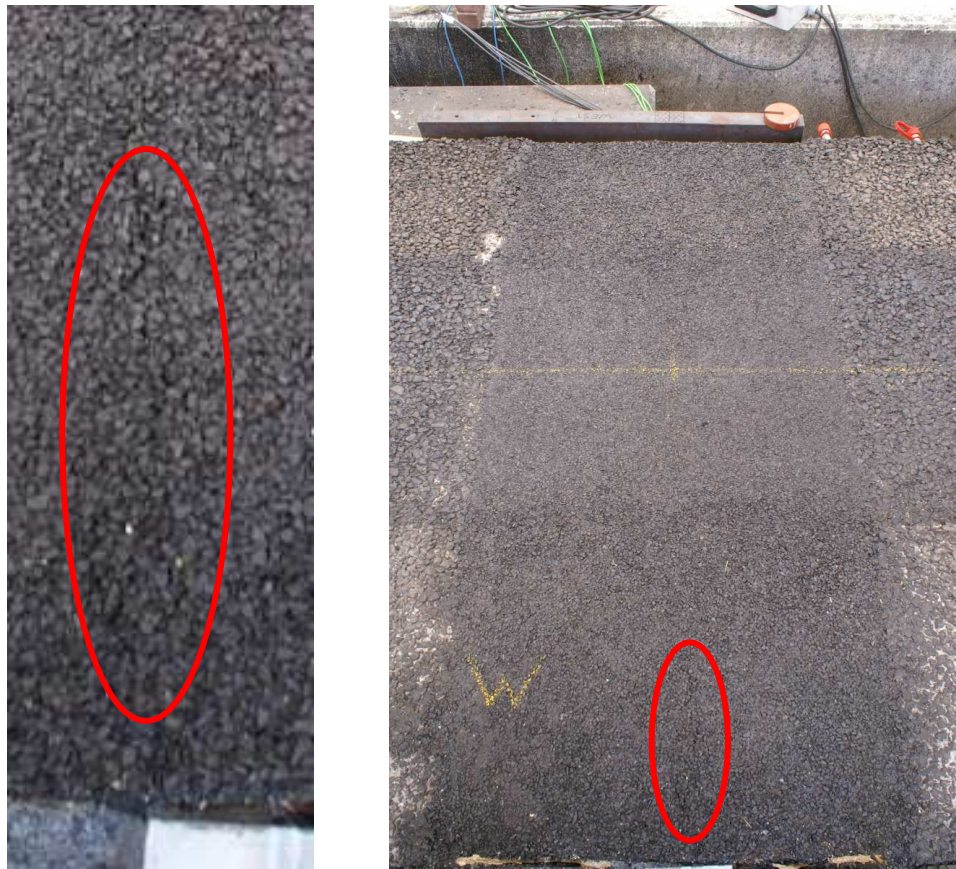
After opening of the +13 mm joint a small surface defect appeared. The defect was hardly visible and appeared to be a non continuous crack in the surface treatment. During trafficking the defect became more visible without growing or progressing.

The defect was located over a thermo couple that was installed into the joint system after its completion and before its opening. Installation of the thermo couple required the drilling of a small horizontal drill hole approximately 15 mm below the joint surface.

Figure 4. Surface defect in +13 mm joint before trafficking (left) and at the end of trafficking (right).

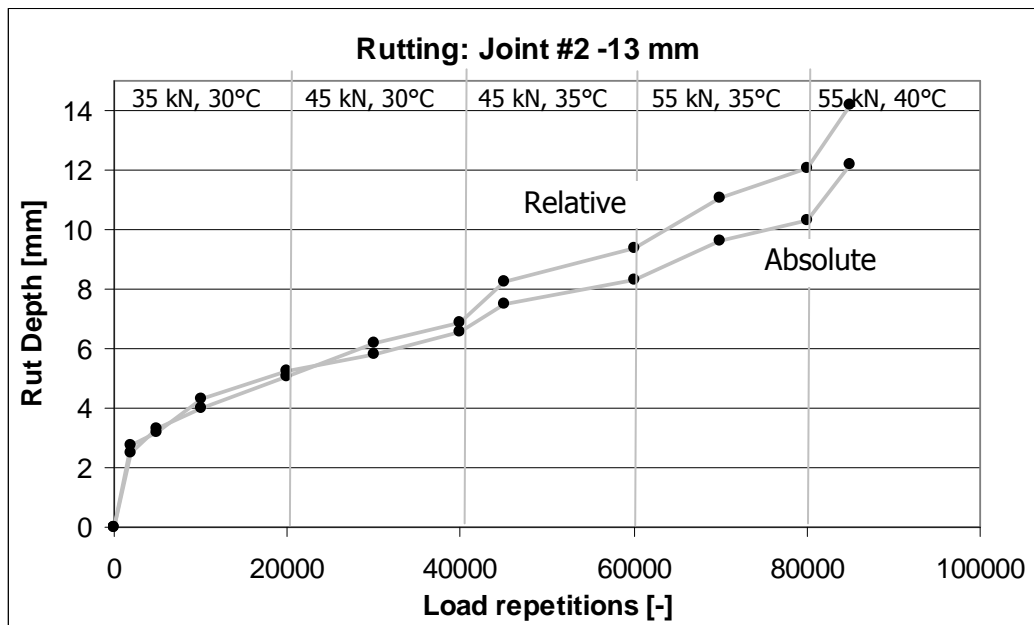
Figure 17. Rutting in the -13 mm joint system.

It is also observed that the absolute rut depth in the -13 mm joint develops at a slightly lower rate than in the +13 mm joint. Due to the observed development of up heaves the opposite is true for relative rut development.

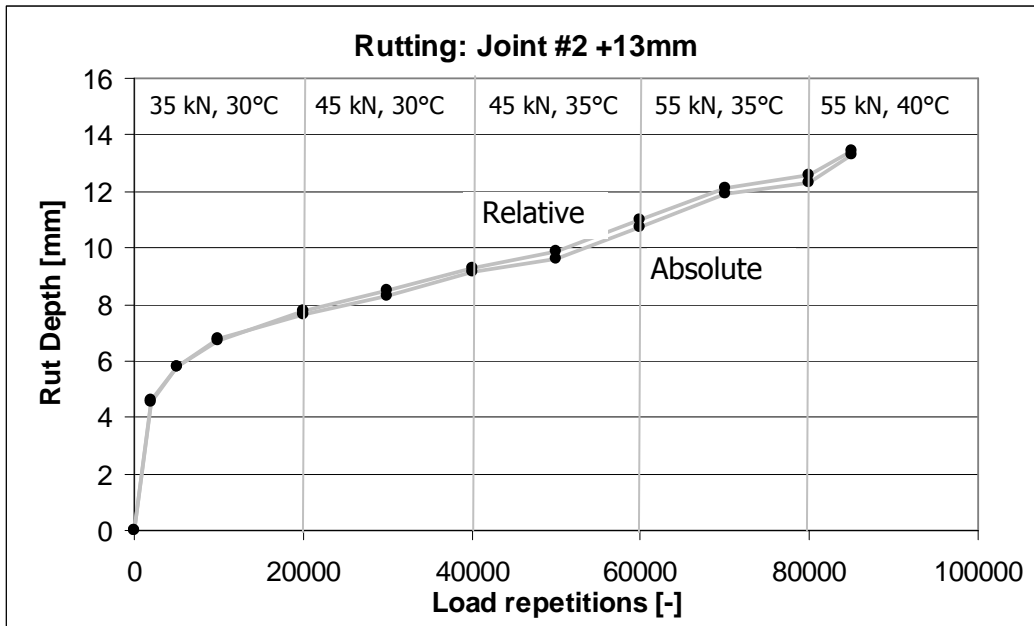
Figure 18. Rutting in the +13 mm joint system.

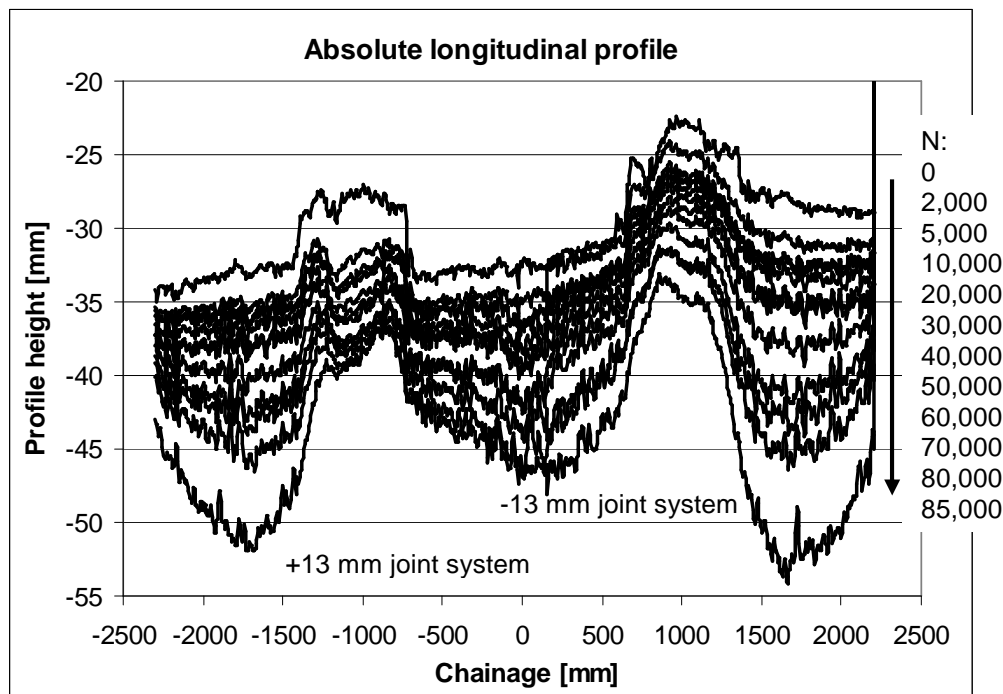
Figure 19 also indicates that rutting in the bridge surfacing structure develops much faster than in the Prefab Silent Joint system. Especially when the temperature reaches 40°C rut development in the bridge surfacing structure progresses at high rate.

Figure 19. Development of the longitudinal profile.

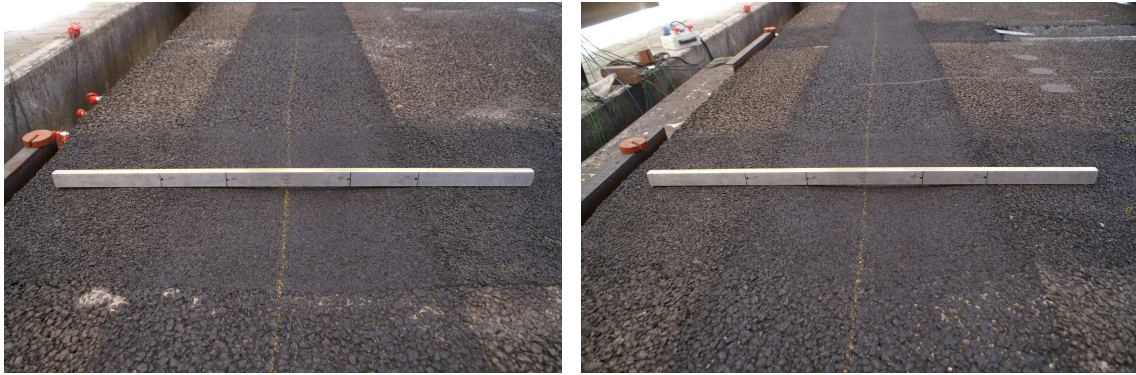
As discussed in the previous section rutting developed in the Prefab Silent Joint system. Figure 21 gives a visual impression of rutting at the end of the test. Furthermore a defect developed while opening the +13 mm joint. This defect was hardly visible at the start of trafficking. During trafficking the defect became pronounced without growing or progressing, also see Figure 4.

Figure 21. Rutting in the Prefab Silent Joint after 85,000 load repetitions. Left: +13 mm joint, right: -13 mm joint. (also see Appendix C)

- The Silent Joint System is purposely installed such that its surface is approximately 5 mm above the surrounding pavement. Given the good rutting performance of the system this may result in long lasting longitudinal unevenness. It is recommended to reconsider construction procedures with respect to this issue.

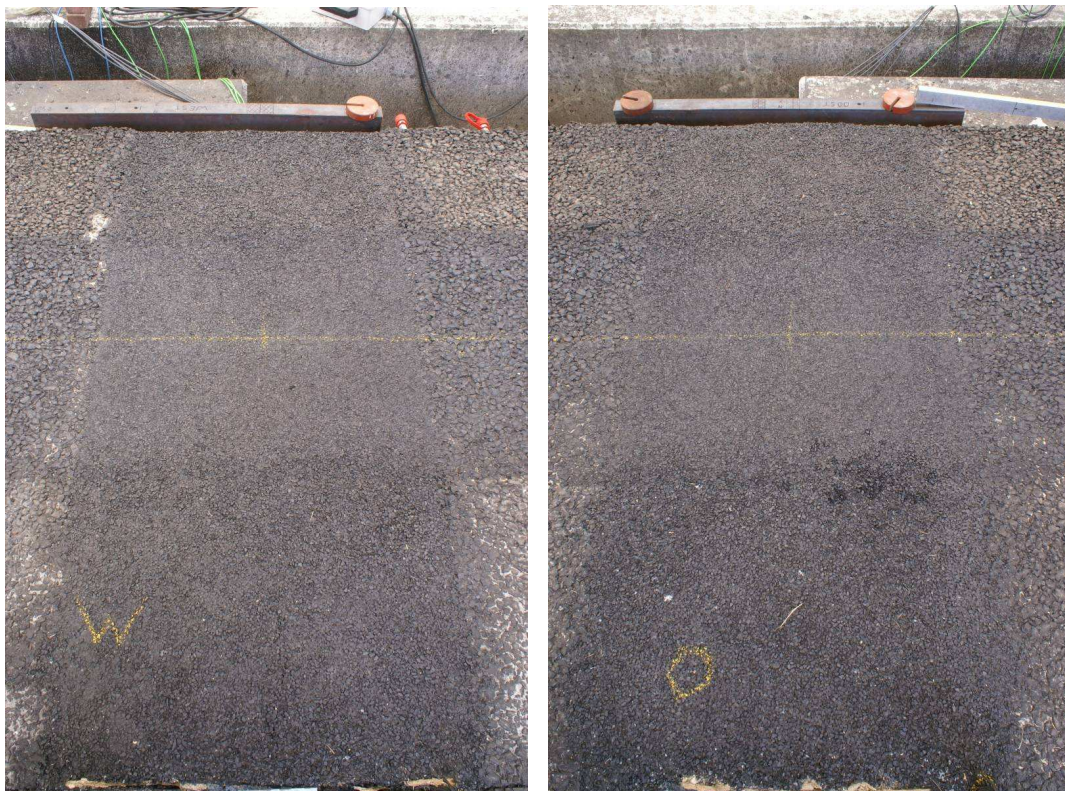
Apart from the above mentioned observations no other damage developed in the Silent Joint system during trafficking, see Figure 22. Reference is made to Appendix C where more photographs made during visual inspections are found.

Figure 22. Status of the tested joints after application of 85,000 load cycles. Left: +13 mm joint, right: -13 mm joint. (also see Appendix C)

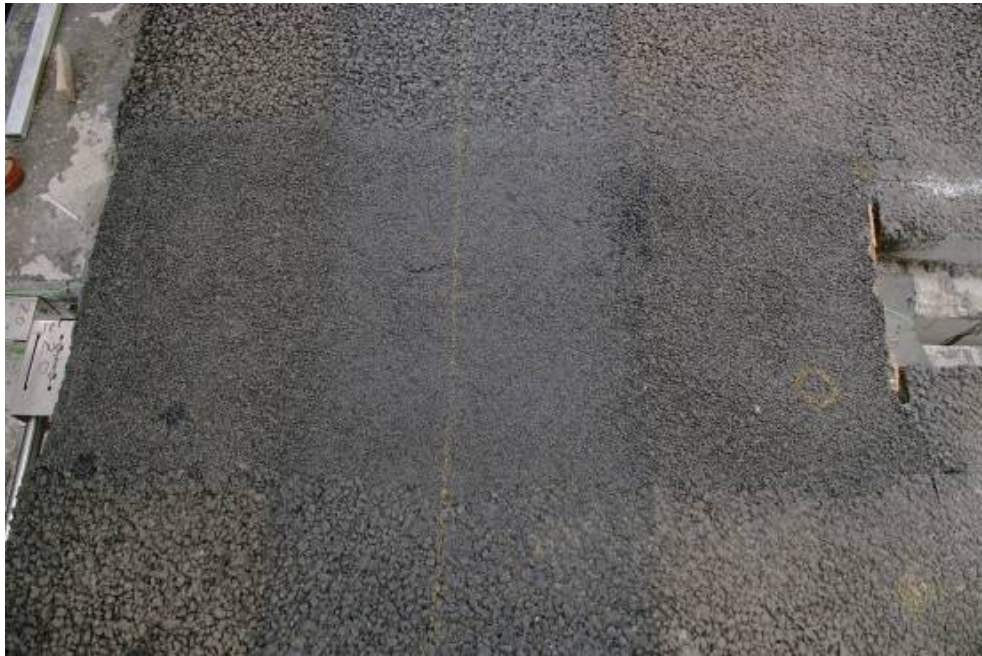
From the photos it is learned that failure of the -13 mm joint is initiated at the wheel path centre. Failure of the +13 mm joint is initiated by the development of

Figure 29. The -13 mm joint just after visual failure. A crack develops at the wheel path centre exactly above the joint between bridge and bridge support.

- It is believed that the Silent Joint System may be further optimised. It was observed that first damage during elongation developed in the middle of the joint. This implies that the built-in springs do not function optimal.
- An interaction between the structural performance of the joint and the surrounding surfacing structure was observed. The causes of this interaction remain unknown. It is recommended to verify these observations during the road test of the Prefab Silent Joint.

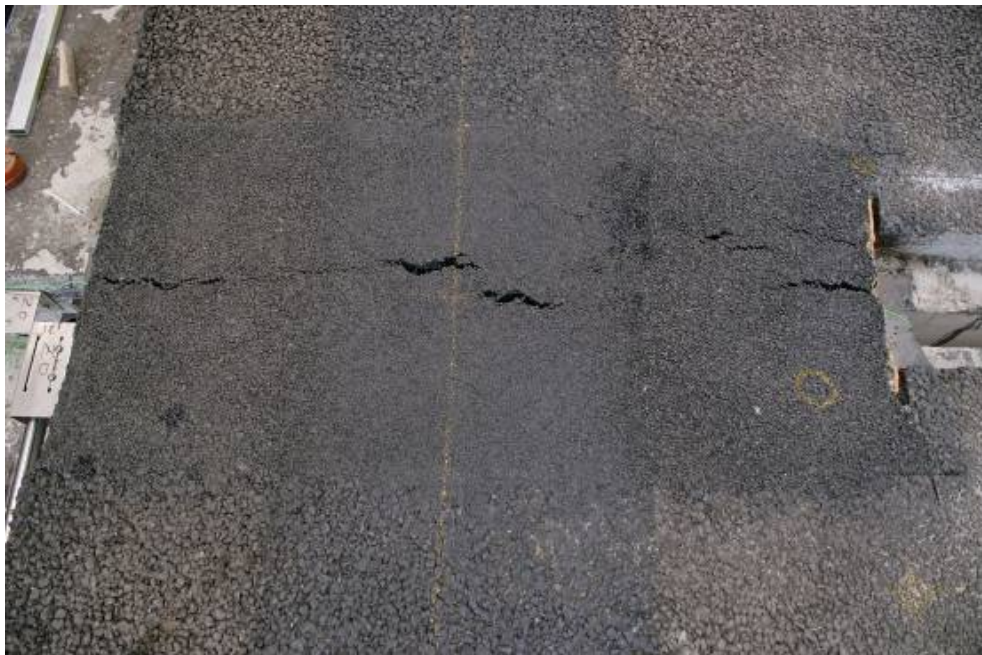
Figure 30. Impression of the -13 mm joint after failure.

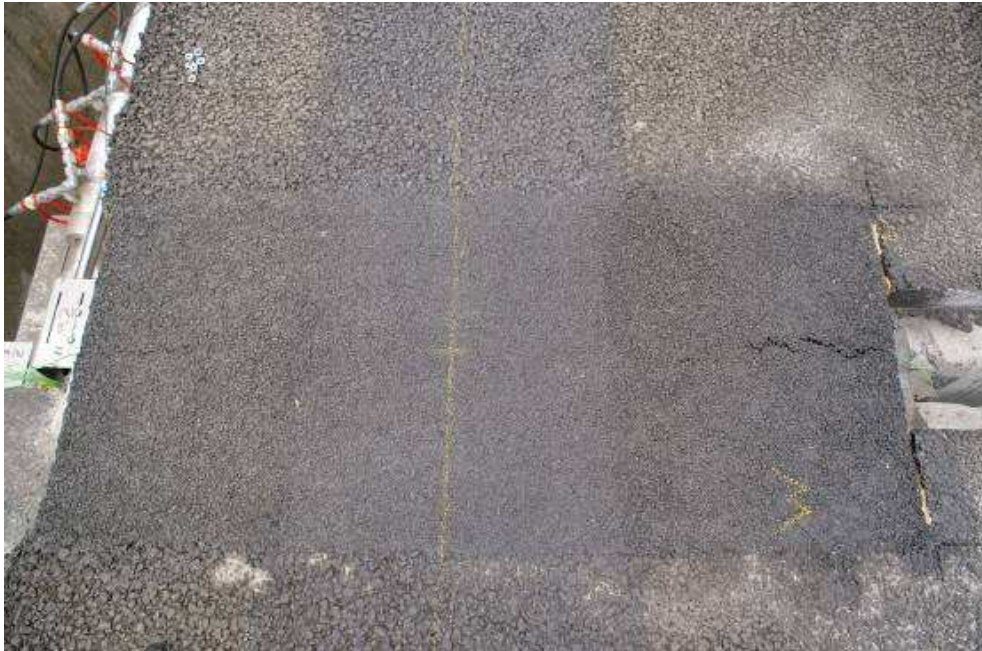
a crack at the joint edge just above a built in temperature gauge, see Figures 29 to 32.

Figure 31. The +13 mm joint at visual failure. A crack develops at the left edge of the joint exactly above the built-in temperature gauge. The crack at the right edge first appeared after initial joint opening.

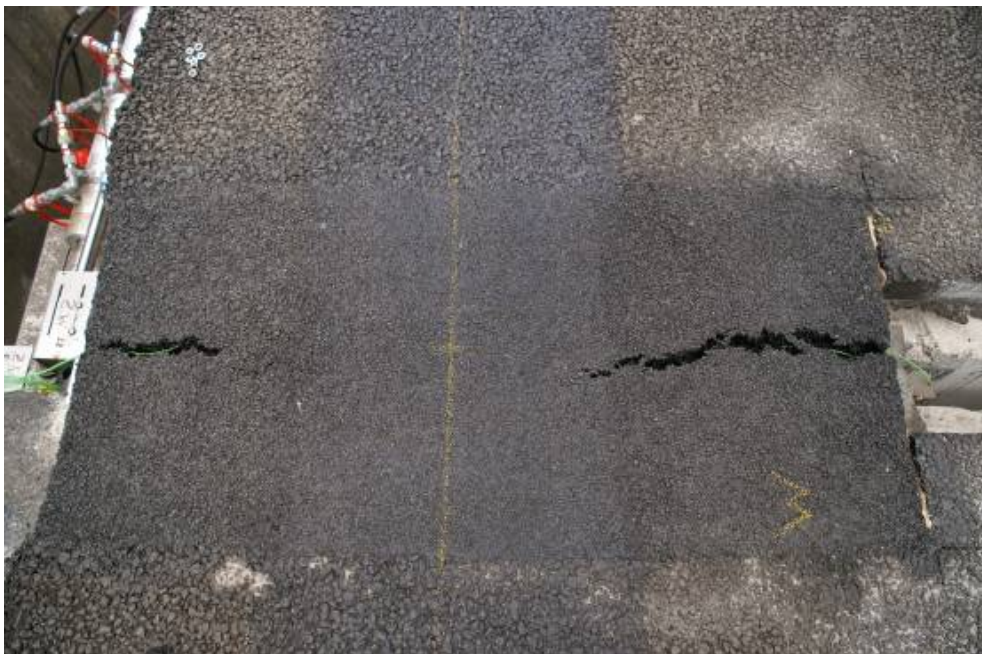
Figure 32. Impression of the +13 mm joint after failure.

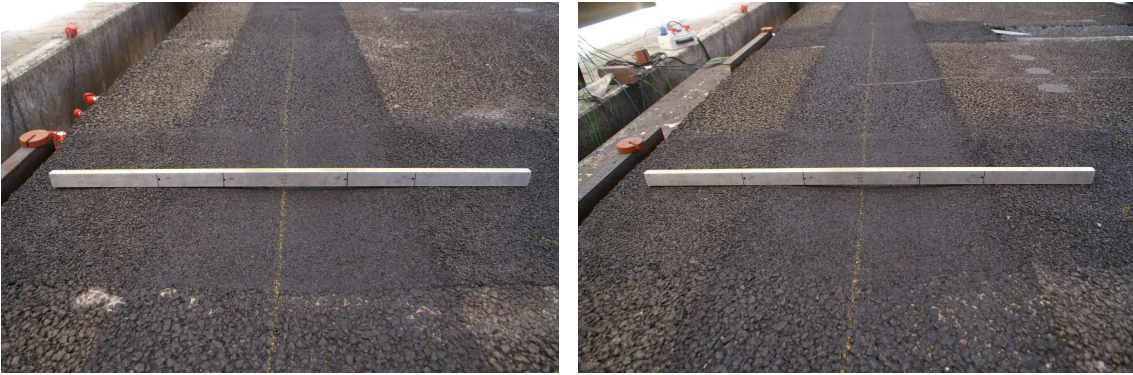
Rutting at N=85000. Left: +13 mm joint, right: -13mm joint.

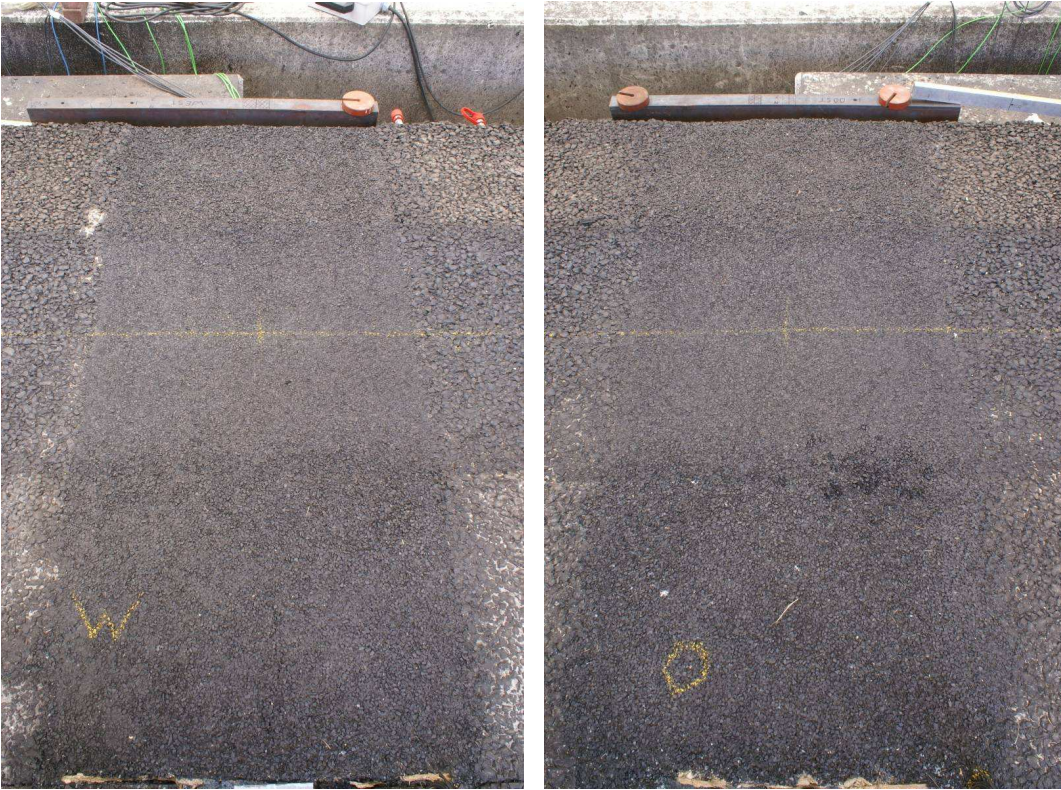
Top view at N=85000. Left: +13mm joint, right: -13mm joint.
