## **Investigation of the rutting behaviour of asphaltic plug joints on the bridges A18 Bielheimerbeek and A58 Daesdonc using Model Mobile Load Simulator MMLS3**

**Test Report No 444110**

**February 2007**

## Test Report No 444110

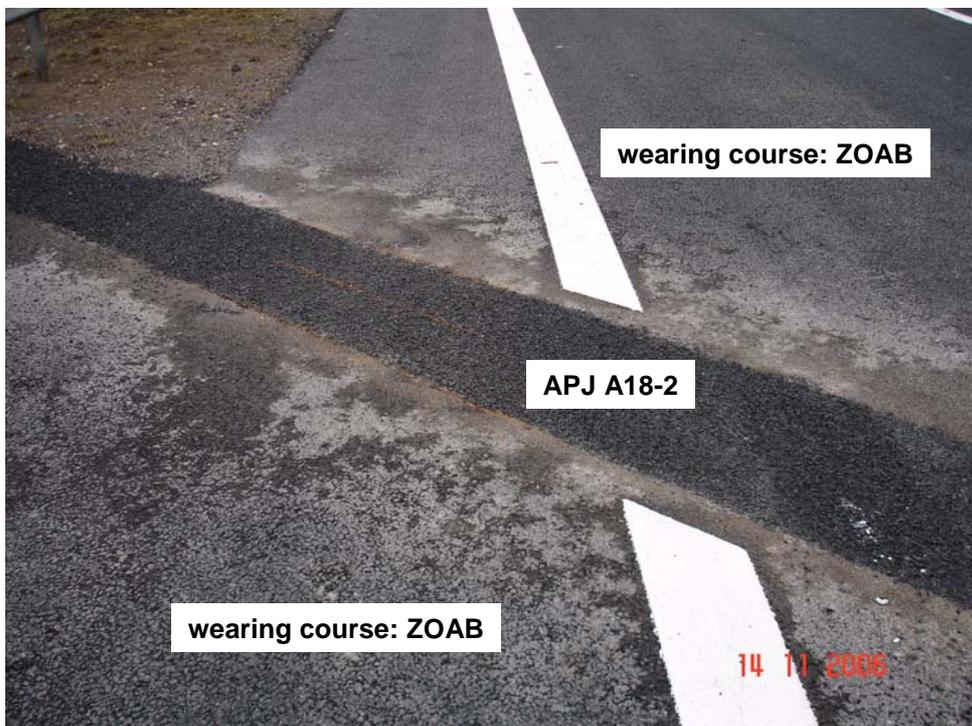
Figure 6.3.2: Appearance of surface dressing of the APJ A18-2

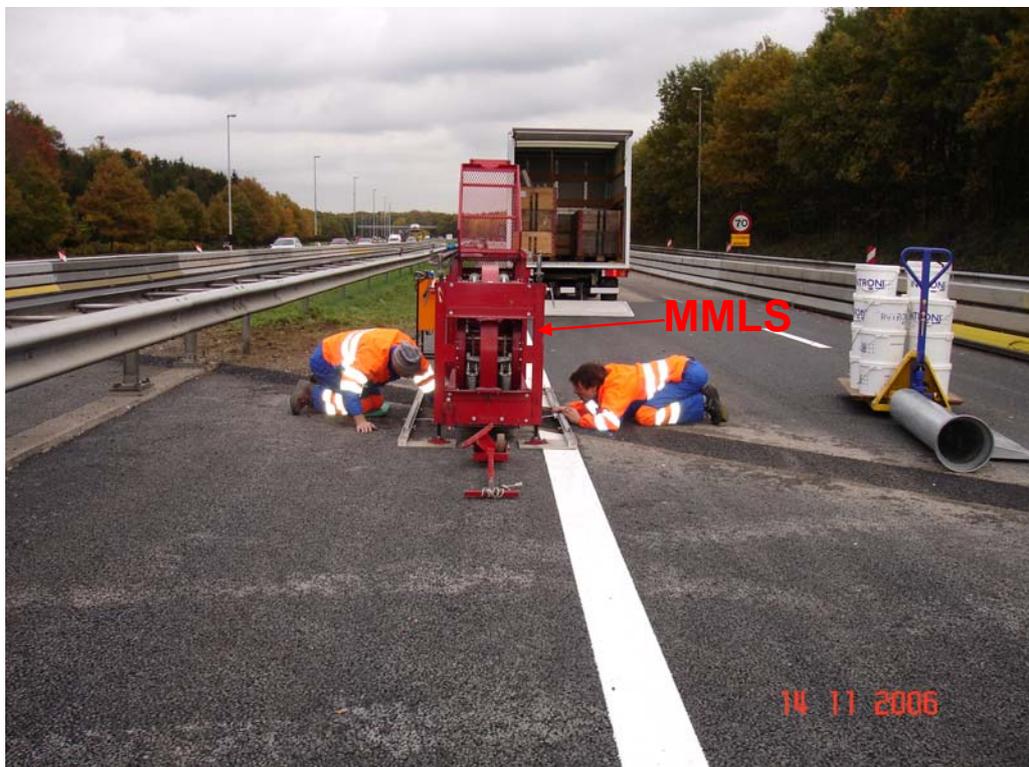
Figure 6.3.4: Device installation for testing the APJ A18-2

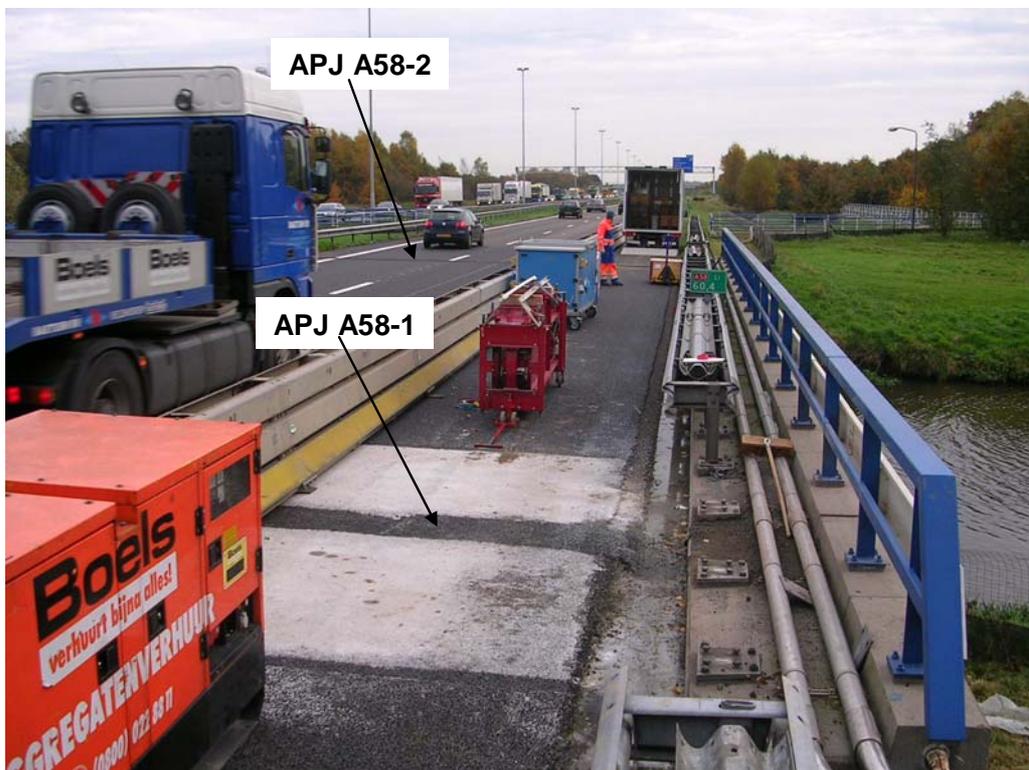
Figure 6.3.6: Test field on the bridge Daesdonc
