LINTRACK research into expansion joint behaviour

Silent Joint 500 Resa S test results

November 2009

Dr.ir. M. Huurman, ing J. Moraal

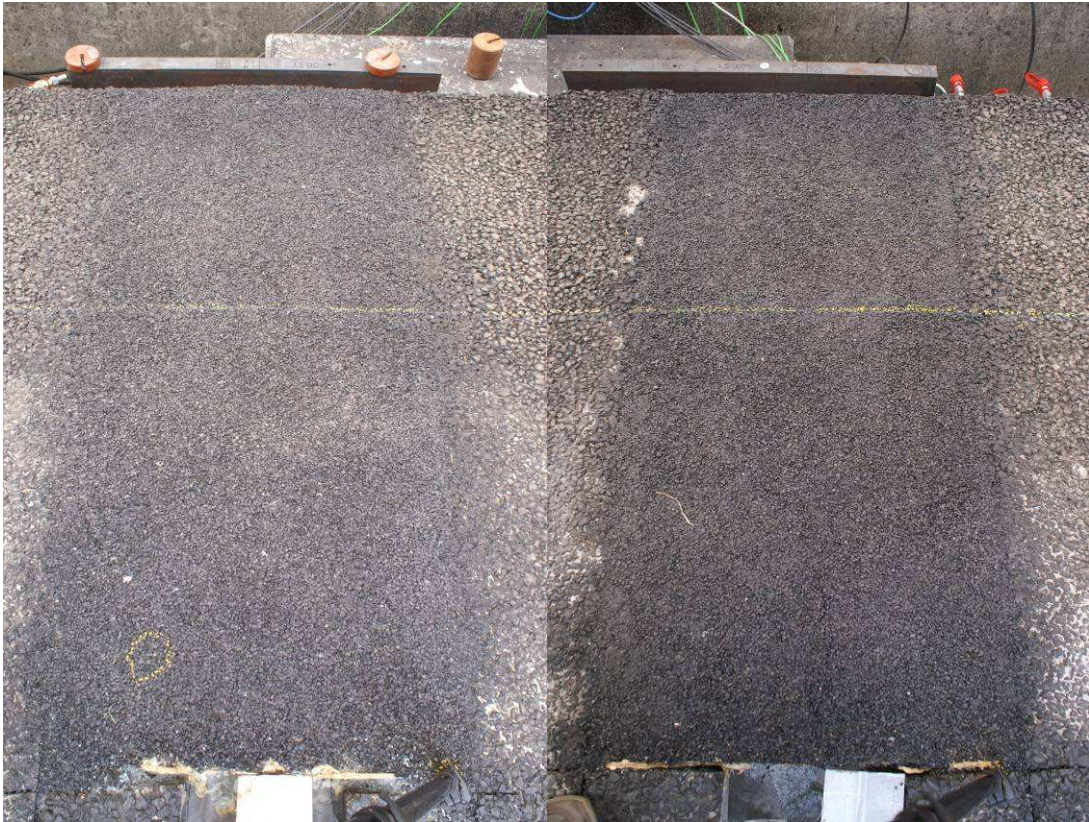
Figure 3. View on the two Prefab Silent Joint systems installed in the LINTRACK facility before trafficking. Left: closed joint, referred to as joint -13 mm. Right: opened joint, referred to as joint +13 mm.

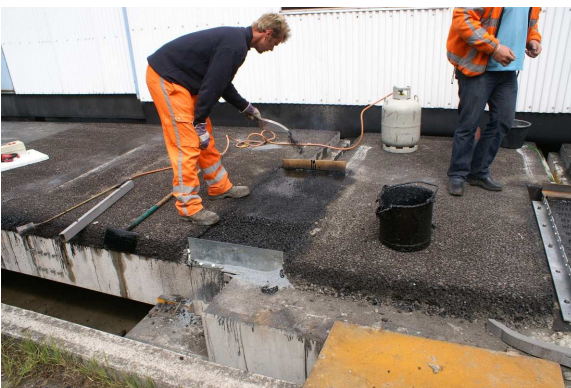
Filling of the trough with prefab joint element. Left: Levelling of the skeleton of pre heated mineral. Right: Bituminous binder is worked into the skeleton of pre heated mineral.

Application of small sized chippings on the Prefab Silent Joint surface.

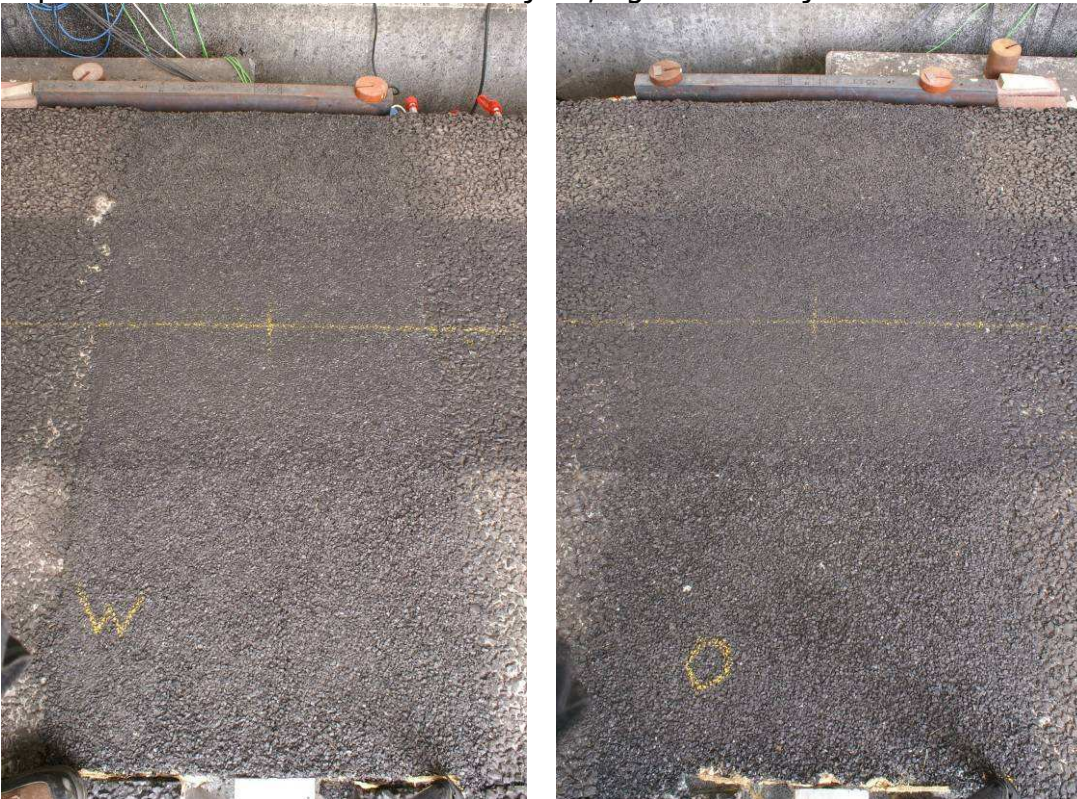
Top view at N=80000. Left: +13mm joint, right: -13mm joint.

- The test on the Prefab Silent Joint system was stopped because of severe longitudinal unevenness caused by depressions in the surrounding surfacing structure.

- The Silent Joint System is purposely installed such that its surface is approximately 5 mm above the surrounding pavement. Given the good rutting performance of the system this may result in long lasting longitudinal unevenness. It is recommended to reconsider construction procedures with respect to this issue.
