LINTRACK research into expansion joint behaviour

Silent Joint 500 Resa S test results

November 2009

Dr.ir. M. Huurman, ing J. Moraal

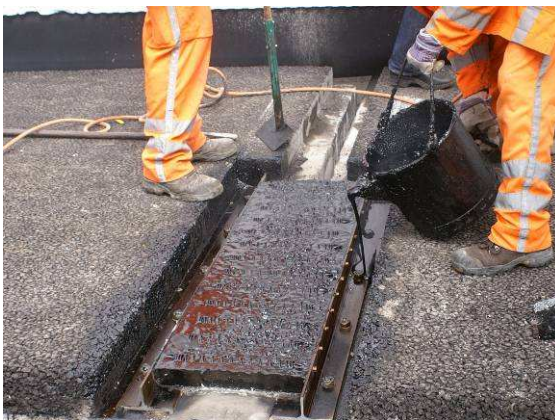
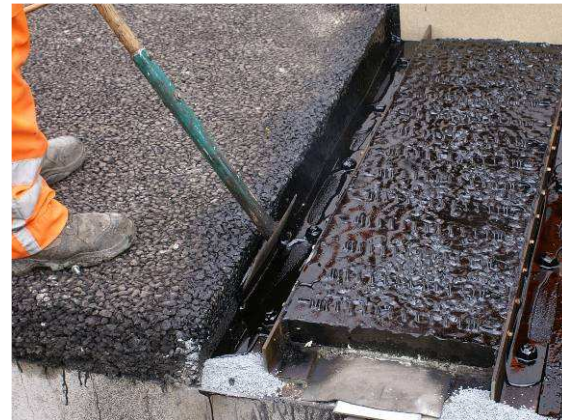
Left: Installation of joint bridging strip. Right: Installation of Prefab Silent Joint.

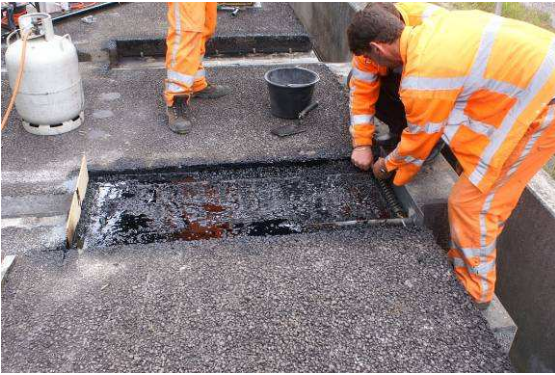
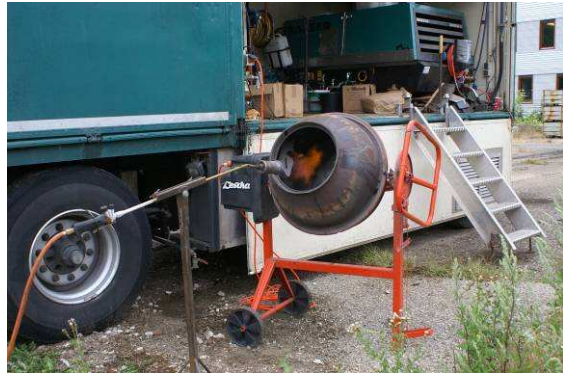
Application of bituminous binder after tightening of the bolts that anchor the prefab element.

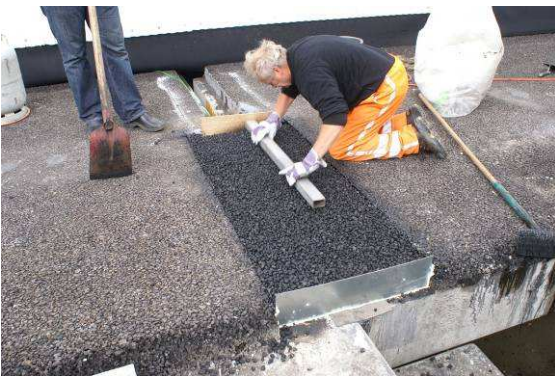
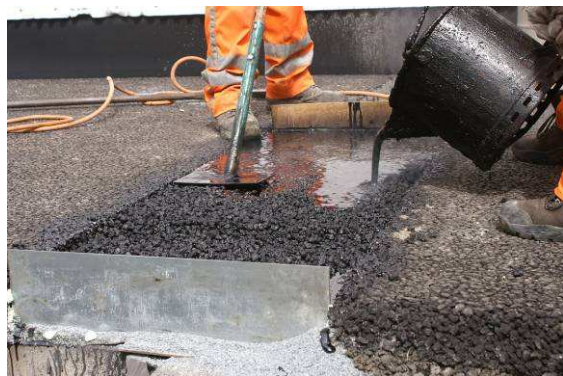
Left: Installation of outer springs. Right: heating of mineral.

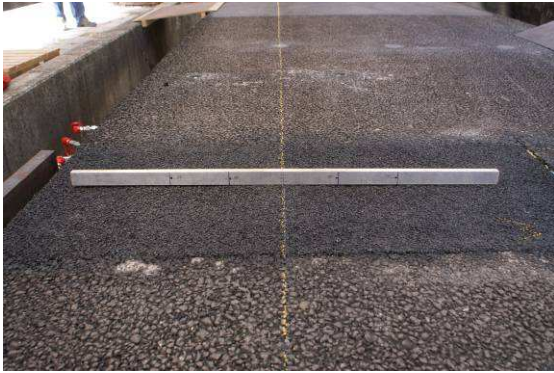
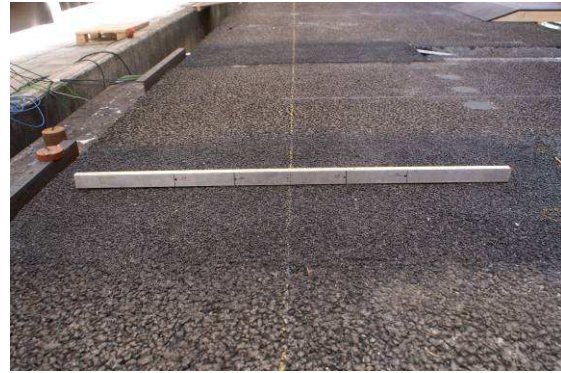
Rutting at N=0. Left: +13 mm joint, right: -13mm joint.

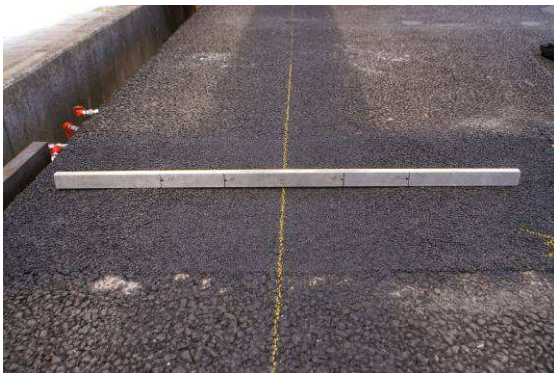
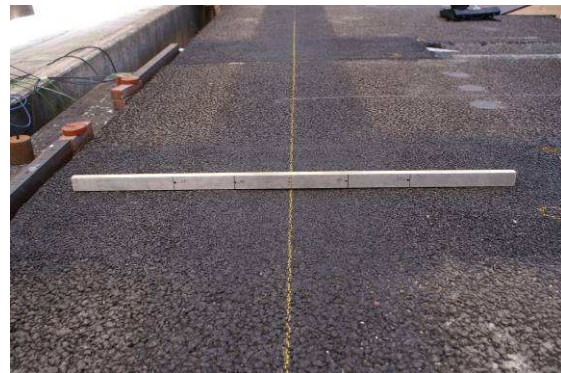
Rutting at N=10000. Left: +13 mm joint, right: -13mm joint.

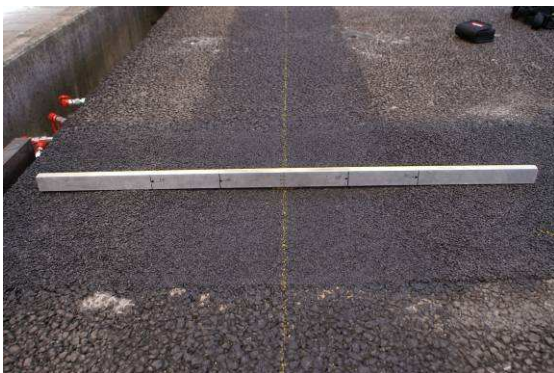
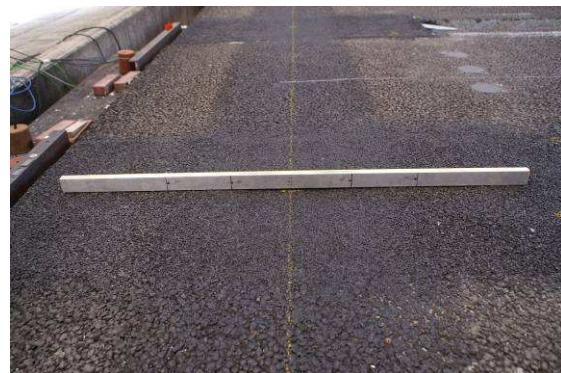
Rutting at N=20000. Left: +13 mm joint, right: -13mm joint.

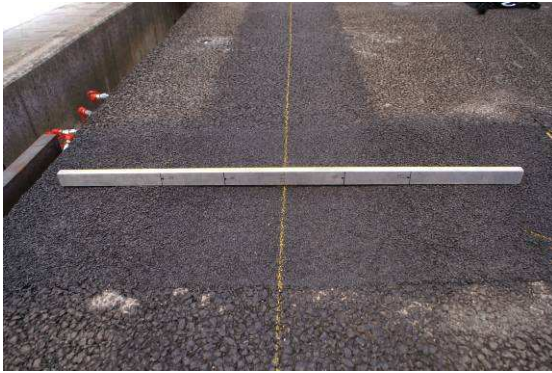
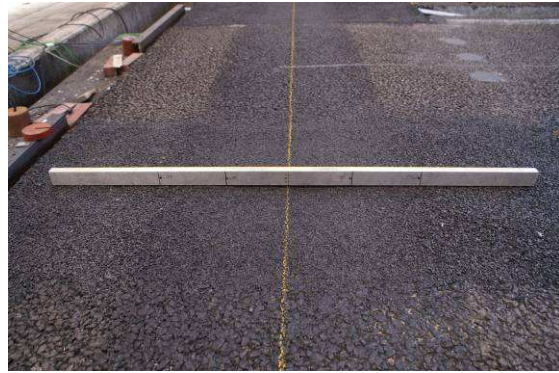
Rutting at N=30000. Left: +13 mm joint, right: -13mm joint.

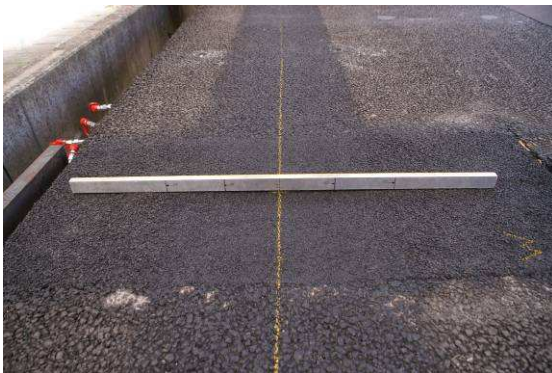
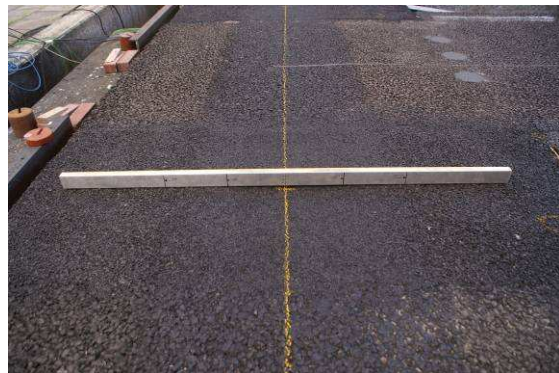
Rutting at N=40000. Left: +13 mm joint, right: -13mm joint.

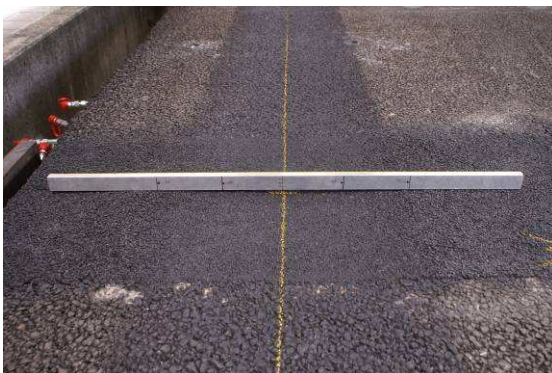
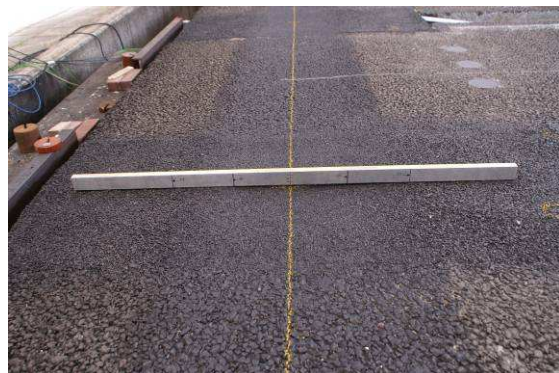
Rutting at N=50000. Left: +13 mm joint, right: -13mm joint.

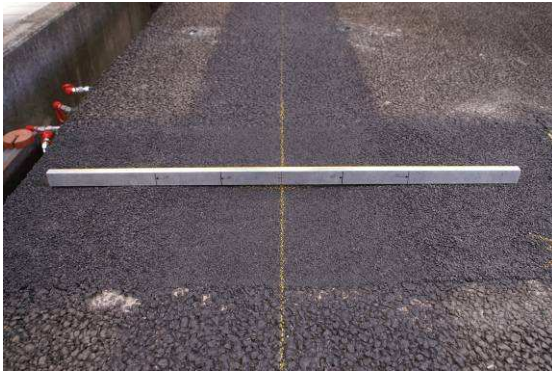
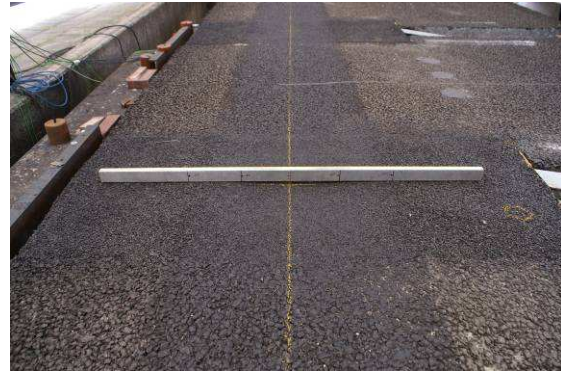
Rutting at N=60000. Left: +13 mm joint, right: -13mm joint.

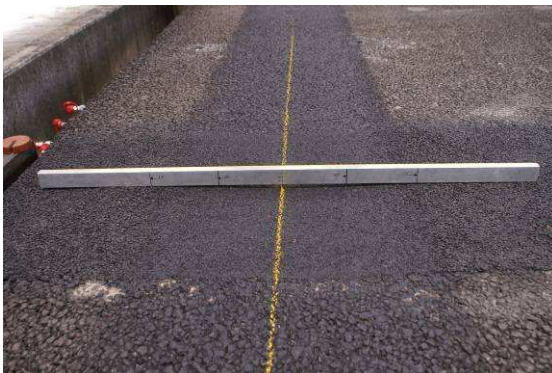
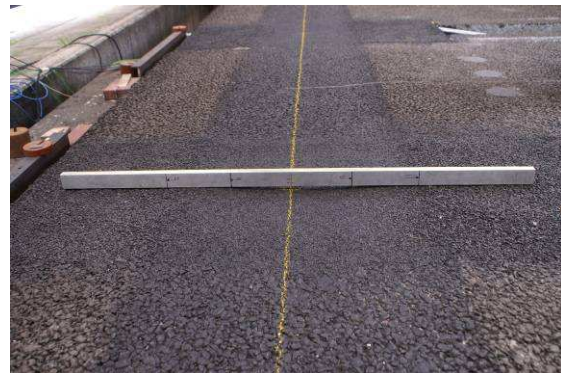
Rutting at N=70000. Left: +13 mm joint, right: -13mm joint.

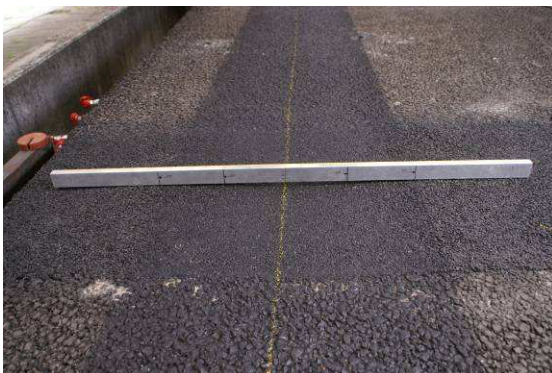
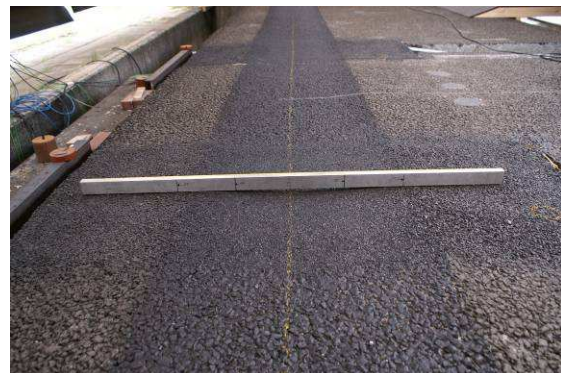
Rutting at N=80000. Left: +13 mm joint, right: -13mm joint.

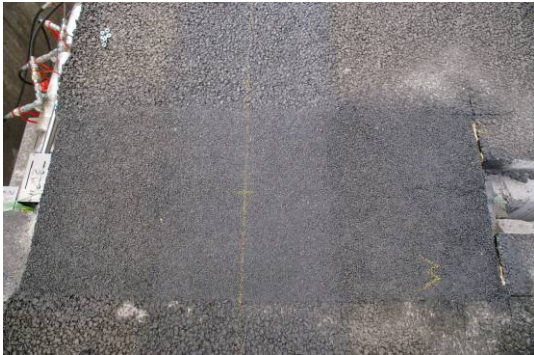
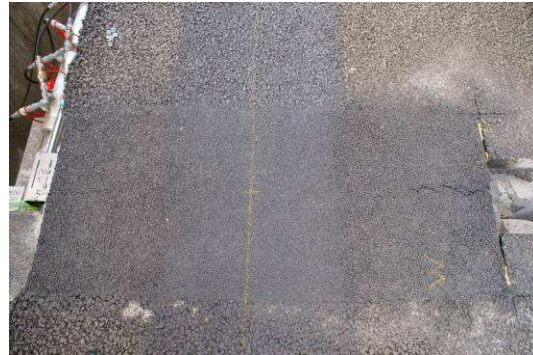
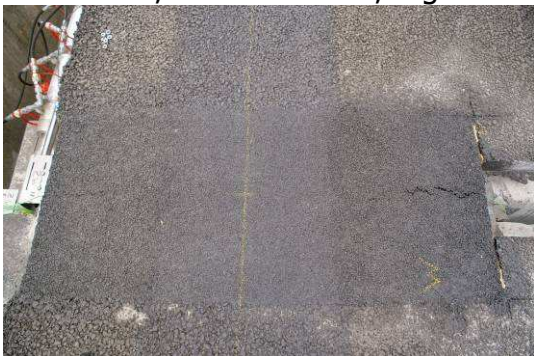
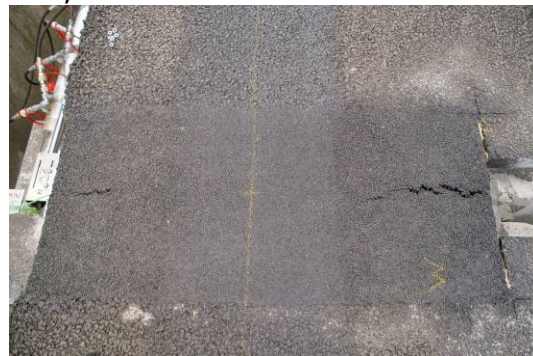
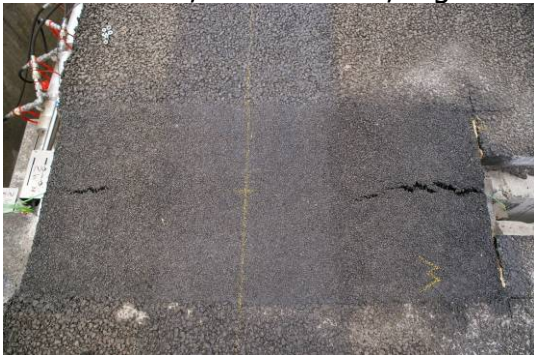
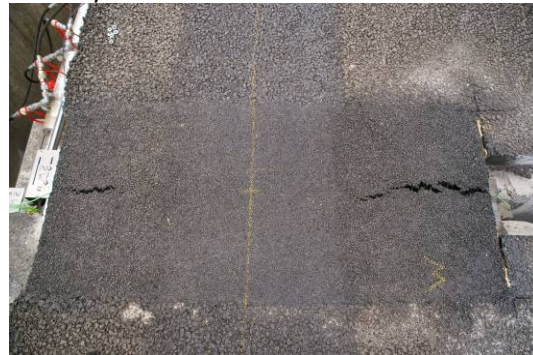
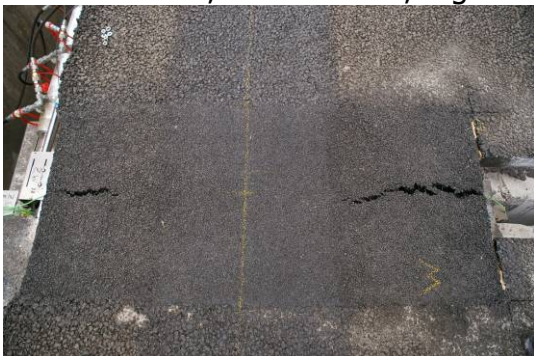
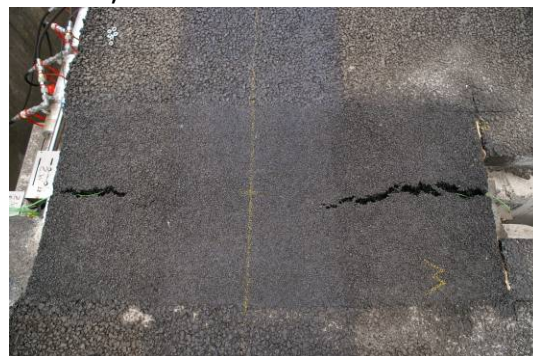
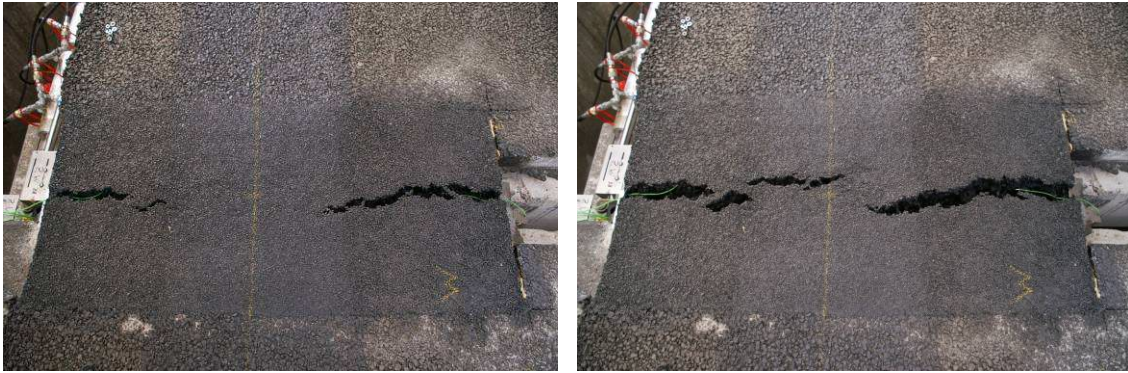
Tension test on the +13 mm joint

- Failure of the Silent Joint System during the static tension test is introduced in the middle of the joint, i.e. over the physical joint in the concrete work.

- The maximum elongation at 25°C to first visual damage is limited to 16 mm on average. The elongation at maximum force is 22 mm on average.
- The results of the static tension test are not much dependant on deformation rate.

- It is believed that the Silent Joint System may be further optimised. It was observed that first damage during elongation developed in the middle of the joint. This implies that the built-in springs do not function optimal.
- An interaction between the structural performance of the joint and the surrounding surfacing structure was observed. The causes of this interaction remain unknown. It is recommended to verify these observations during the road test of the Prefab Silent Joint.
